Home Inspection Report

24 Stark Road, Glenfield, California

Terry Sun
Demo Company 2
12/07/2016
Sample 0001

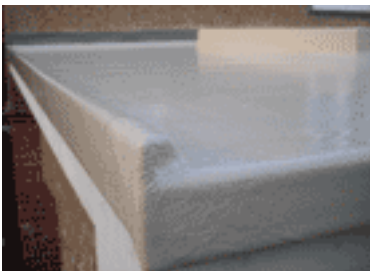
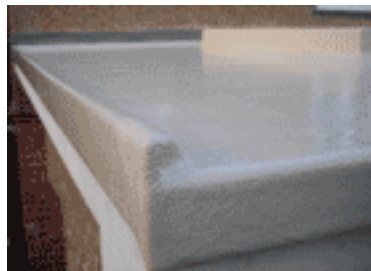
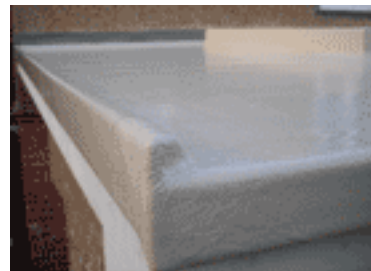
Roof Coverings
2016-07-12 01:50:08

Comments: The roofing material was fiberglass based asphalt shingles that appeared to be in the second third of their life cycle

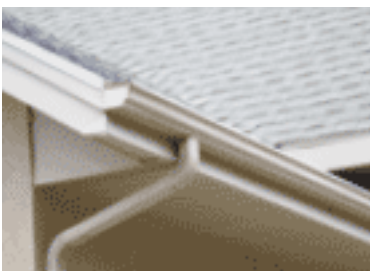
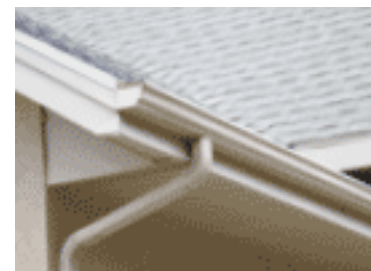
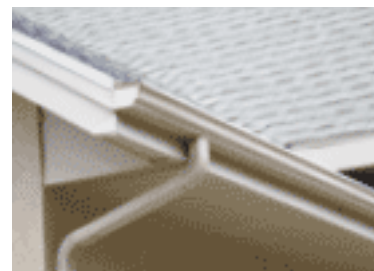
Gutters
2016-07-12 02:12:34

Comments: Minor leaks in the gutters should be repaired.

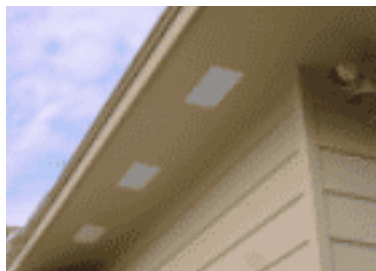
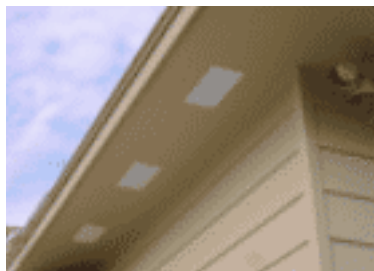
Eaves, Soffits, Fascia
2016-07-12 01:50:08

Comments: Good condition.

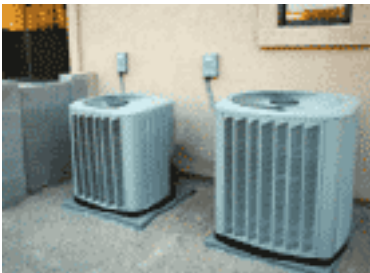
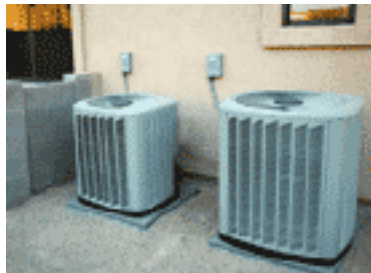
Cooling System 1
2016-07-12 22:22:17

- **Repair Required:** The insulation is missing or damaged at interior refrigerant line. A qualified person should repair as needed.

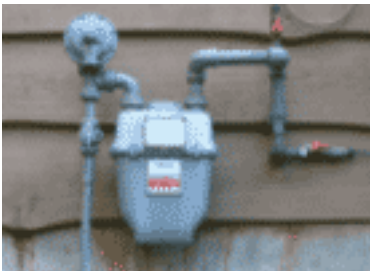
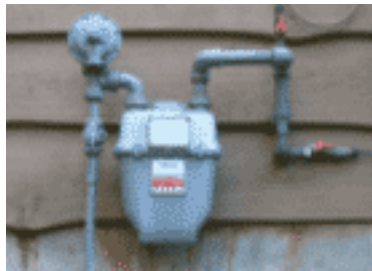
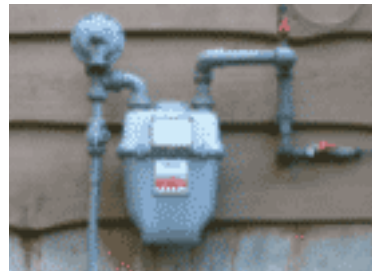
Main Fuel Supply
2016-07-12 22:22:17

Comments: No Gas detected. Cut off valves working perfectly.

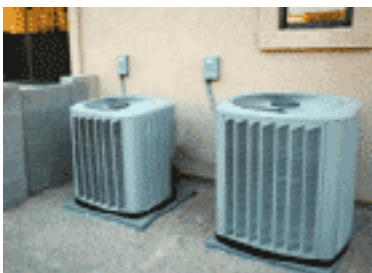
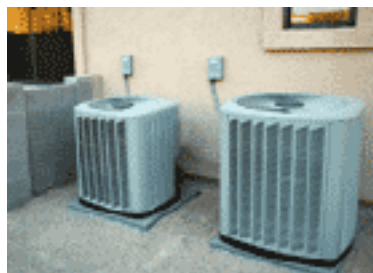
Cooling System 1
2016-07-12 22:22:17

- **Repair Required:** The insulation is missing or damaged at interior refrigerant line. A qualified person should repair as needed.
